## HEAT LOSS REPORT

**Date of survey:** 6th December 2022

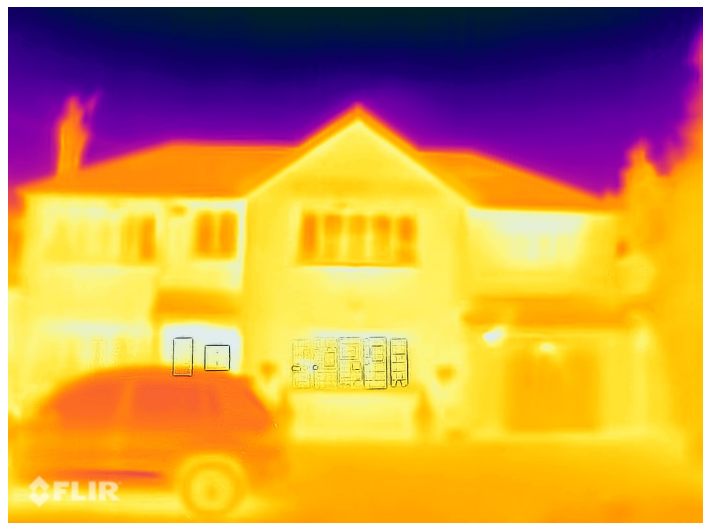
The front of the house shows the majority of the heat loss appears to through the front door and the walls of the property. The house has been extended to the right of the image. The older part of the house doesn't have cavity wall insulation whereas the extended part does.

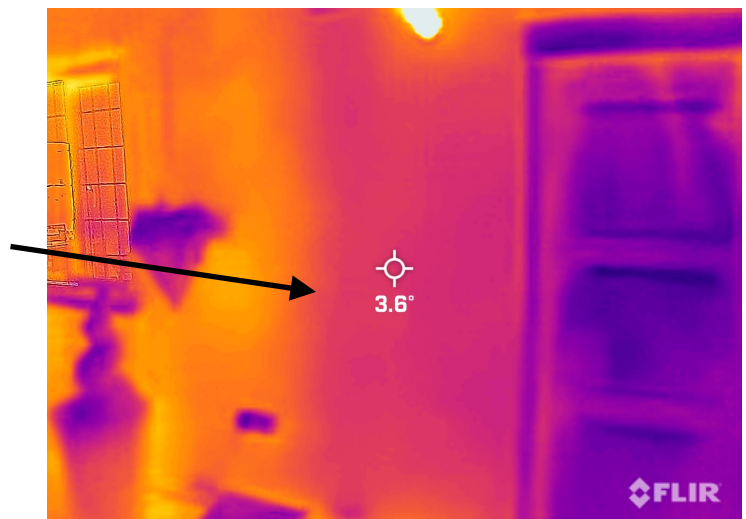
Note the differences in the heat lost in the older build of the house without cavity wall insulation on the left, compared with the newer extension with mineral wool insulation on the right.

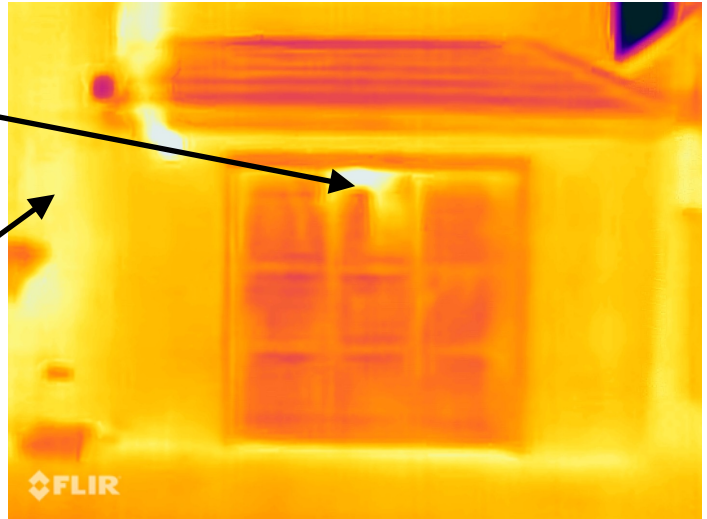
The garage door appears to have a lack of insulation in the middle upper part of it leading to heat loss.

In this image there is also the heat from the boiler pipes coming through the wall below and to the left of the flue pipe.

**Remedy** - This is a faux door that can be removed and appropriate insulation added. Inside the boiler pipes can be insulated to prevent excessive heat being transferred through the bricks.

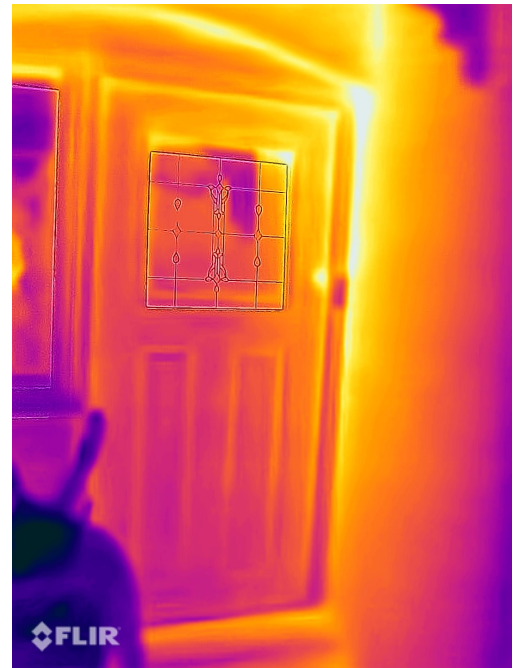
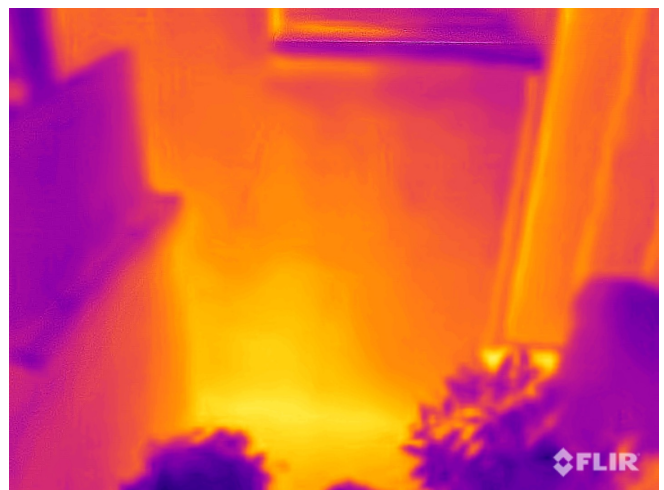
The front door is a modern composite that has very effective seals and draught proofing. However there is significant heat loss to the side of the door and underneath the window to the left.

**Remedy** - Cavity wall insulation would limit the heat loss through walls. The panel to the side can either be removed and insulated within the cavity or insulation and plaster board can be added on the inner panel to limit heat loss.

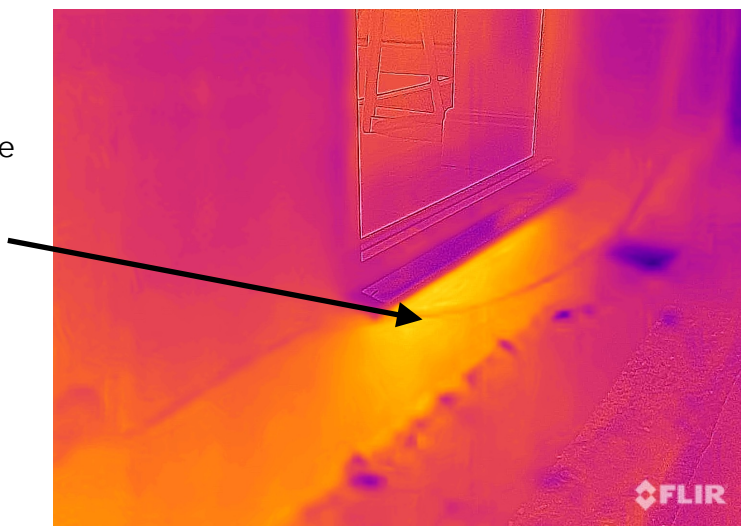
The large window to the side of the house appears to have little or no cavity wall insulation underneath it.

**Remedy** - Injecting insulation through a bore hole

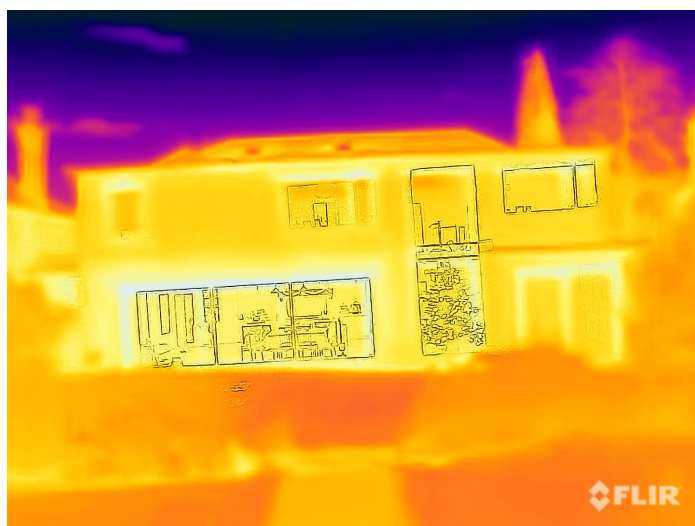
The rear of the property is a newly built extension that is showing excellent insulation with no noticeable gaps or excessive heat loss..

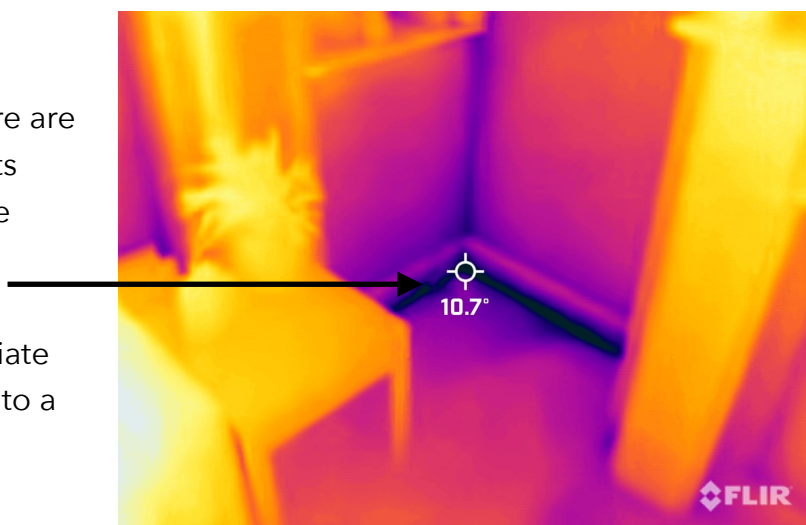
In the lounge and the playroom there are significant cold spots due to draughts through between the skirting and the suspended wooden floor.

**Remedy** - Fill the gaps with appropriate insulation. Also consider upgrading to a thicker, higher tog underlay.

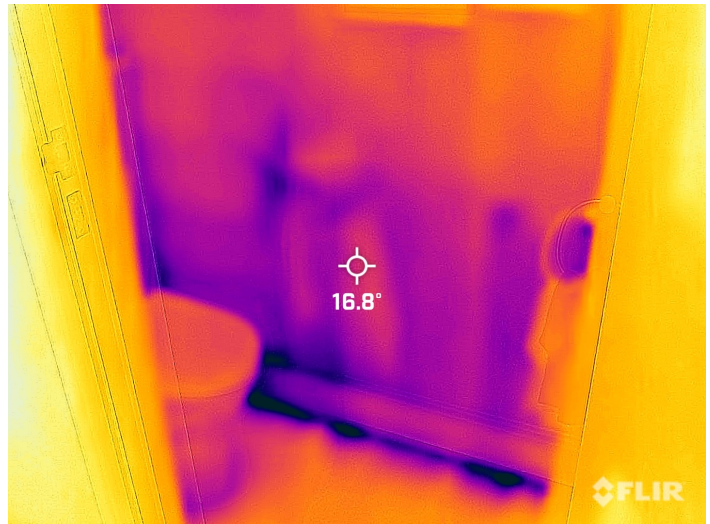
There are significant cold spots in the downstairs toilet. There appears to be patchy insulation which correlates with the heat losses on the garage door.

**Remedy** - Insulating behind the garage door. Insulate the gaps between the floor and the skirting board.

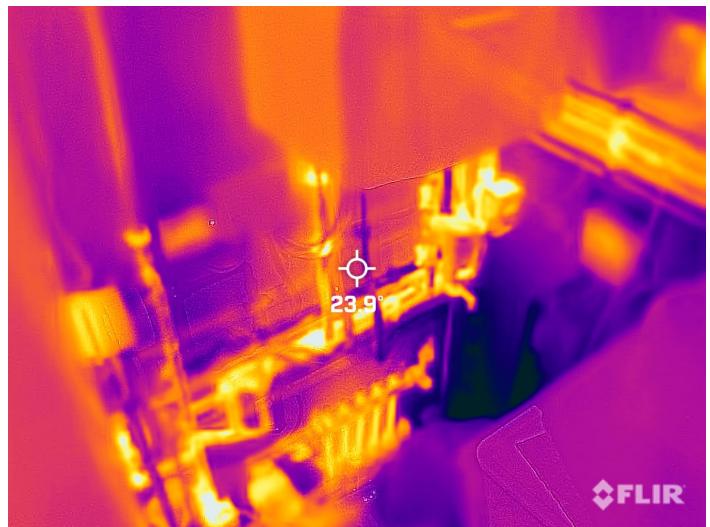
The boiler room shows a very cold spot where there is a gap in the floor with no insulation and this gap penetrates the internal skin causing the warm patch on the outside. The pipes are also very hot and heating this space rather than the rooms.

**Remedy** - Fill and insulate the void, then add cover panels. Lag and insulate all pipework.

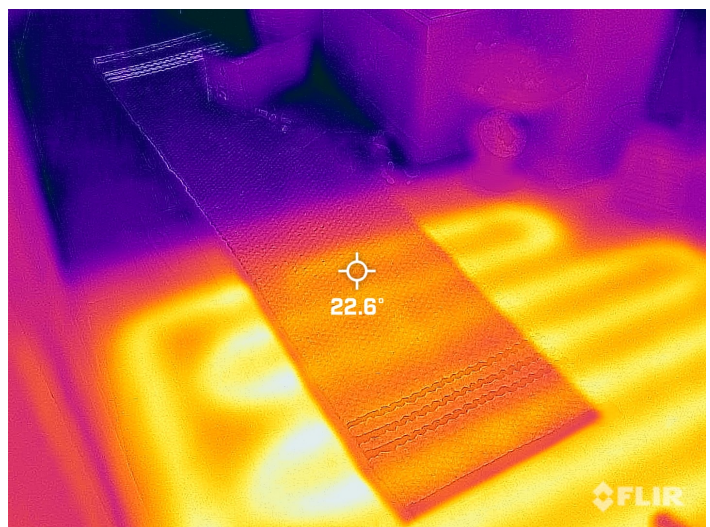
There are several rugs positioned over the underfloor heating. These are limiting the effectiveness of the UFH to transmit the heat to the room.

**Remedy** - Remove the rugs or only position them on the non heated part of the floor. Only use natural fibres with a high capacity to transmit the heat through the material.

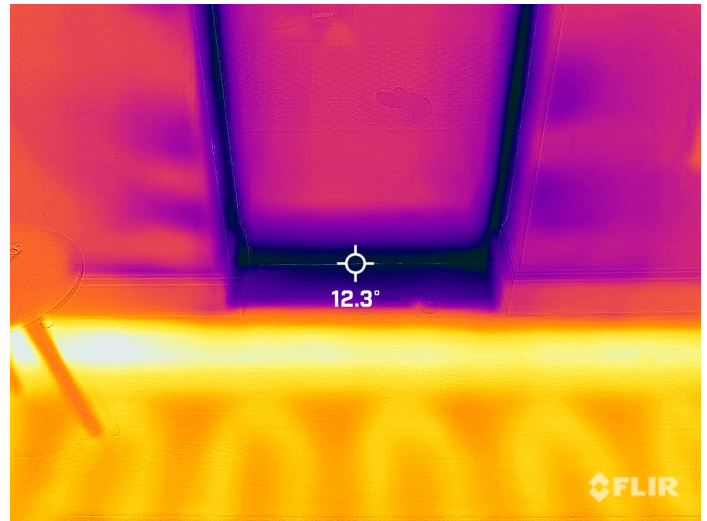
Cold uninsulated spot next to the large kitchen window as per outside view.

**Remedy** - Cavity underneath to have appropriate insulation blow to fill the void.

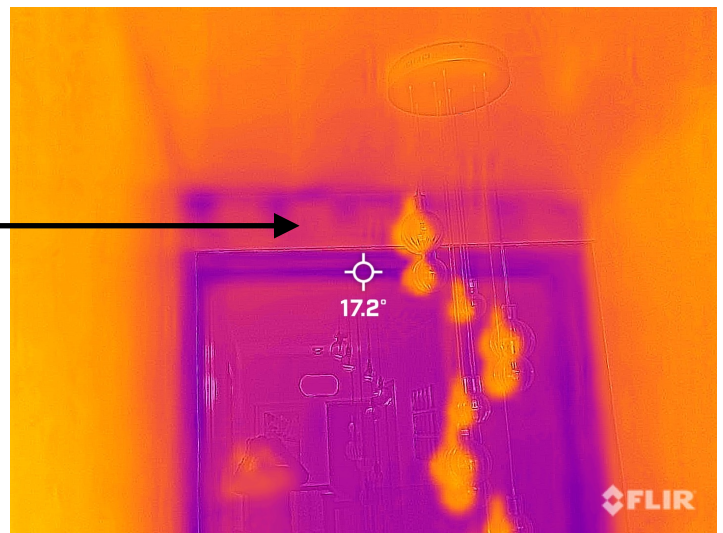
The large window in the hallway is lacking insulation in-between the frame and the roofline.

**Remedy** - Local Cavity wall insulation injected.

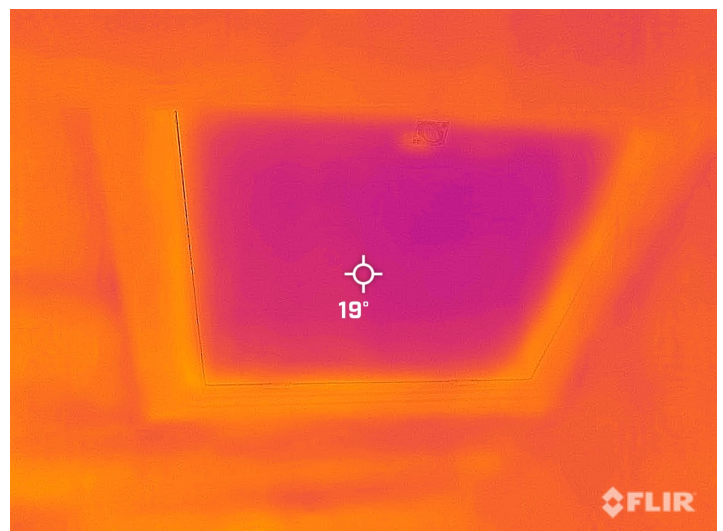
The loft hatch is a cold spot despite it having a thin layer of insulation on it. It doesn't however have any draught seals.

**Remedy** - Thicker insulation to be installed on the hatch and draught seals to be put around the edges.

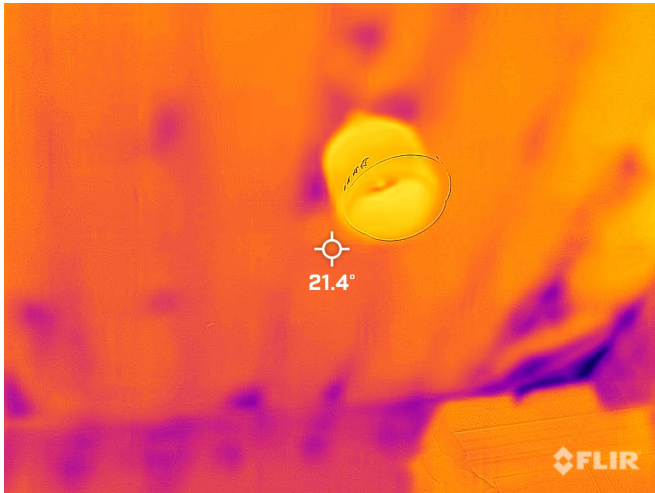
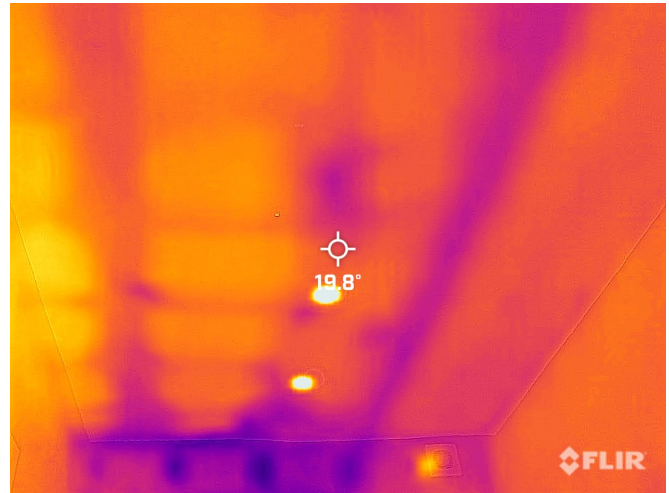
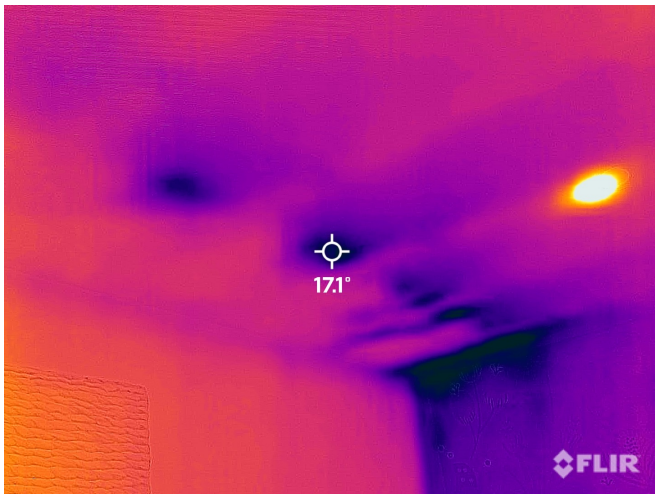
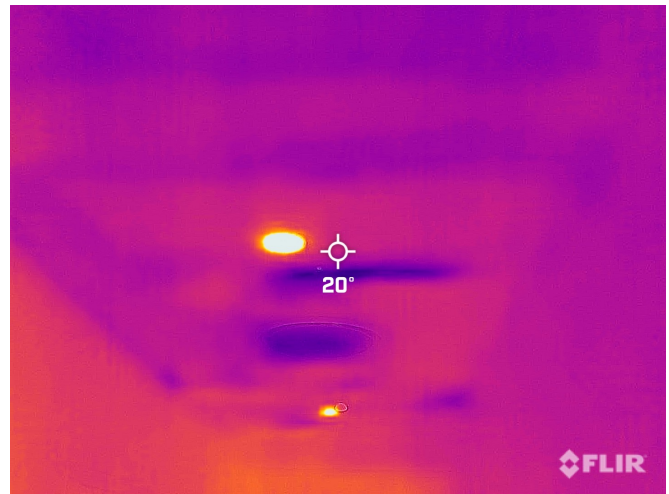
All of the bedrooms had cold patches where the loft insulation had either been removed or wasn't effectively placed.

**Remedy** - On closer inspection this is due to the insulation being moved and not installed correctly. This would need a new layer to increase the thickness especially over the gaps and a repositioning to those areas that are lacking.
